**RE: 1799 York Avenue, St. Paul, Minnesota
Asbestos, Lead, and Hazardous Materials Inspection
IEA Project #201910288**

**ASBESTOS, LEAD &
HAZARDOUS MATERIALS INSPECTION
PROFILE**

**Single Family Residence
1799 York Avenue
St. Paul, Minnesota 55119**

IEA Project #201910288

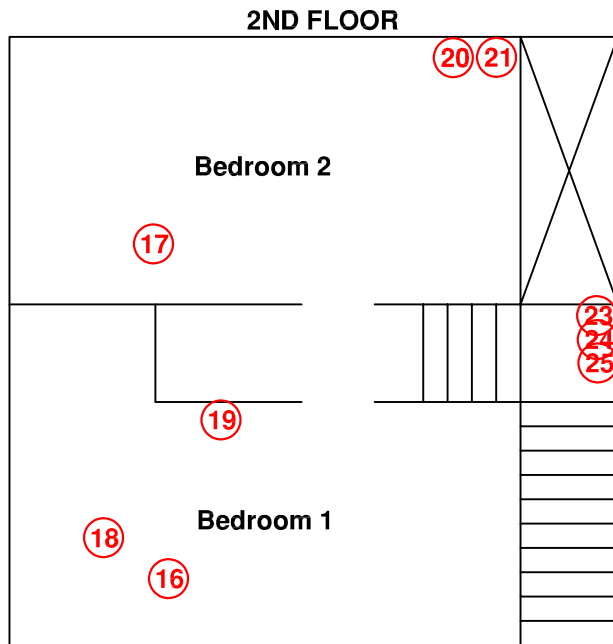
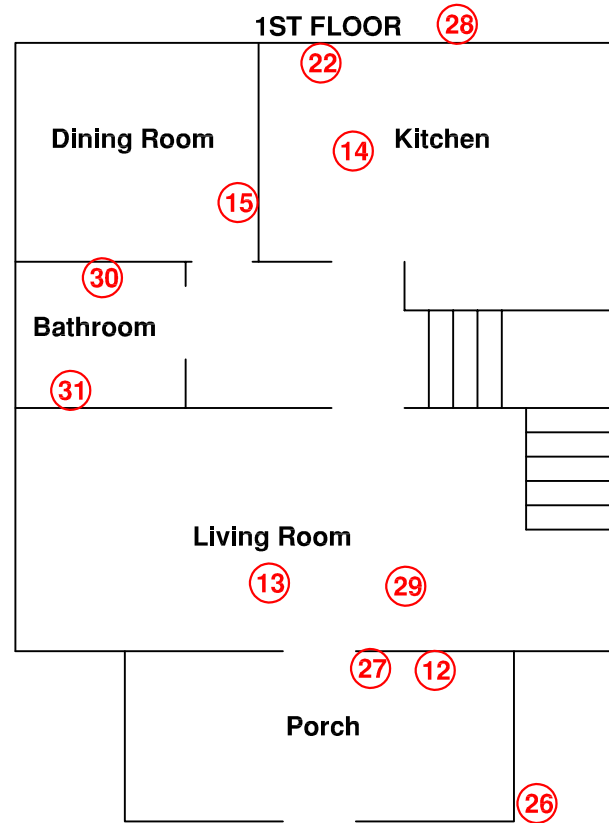
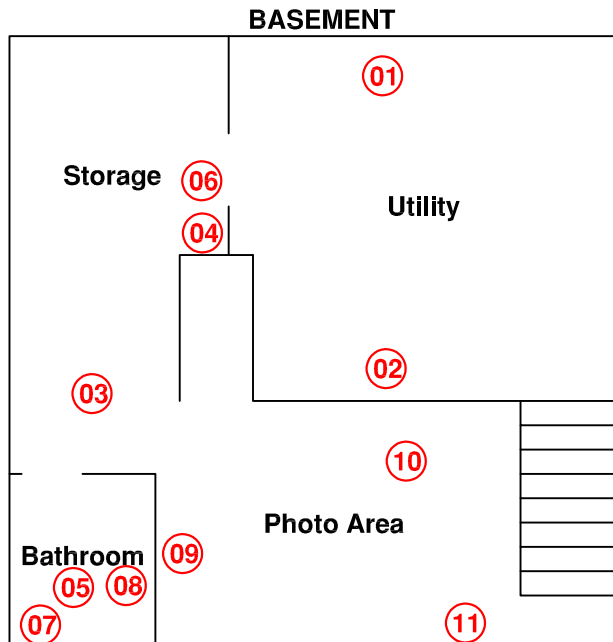
Mar. 2019 | Figure 01

1799 York Avenue, St. Paul, MN, Sample Location Map
